DEPARTMENT OF TRANSPORTATION

Contract #: 04-0120F4Cty: SF/ALA Rte: 80 PM: 13.2/13.9File #: 69.28**WELDING INSPECTION REPORT****Resident Engineer:** Pursell, Gary**Address:** 333 Burma Road**City:** Oakland, CA 94607**Report No:** WIR-000580**Date Inspected:** 06-Oct-2007**Project Name:** SAS Superstructure**OSM Arrival Time:** 1300**Prime Contractor:** American Bridge/Fluor Enterprises, a JV**OSM Departure Time:** 2330**Contractor:** Zhenhua Port Machinery Company, Ltd (ZPMC), Changxing Island **Location:** Shanghai, China**CWI Name:** Zhu Zhong Hai**CWI Present:** Yes No**Inspected CWI report:** Yes No N/A**Rod Oven in Use:** Yes No N/A**Electrode to specification:** Yes No N/A**Weld Procedures Followed:** Yes No N/A**Qualified Welders:** Yes No N/A**Verified Joint Fit-up:** Yes No N/A**Approved Drawings:** Yes No N/A**Approved WPS:** Yes No N/A**Delayed / Cancelled:** Yes No N/A**Bridge No:** 34-0006**Component:** 77 & 89 Meter Mock-Ups**Summary of Items Observed:**

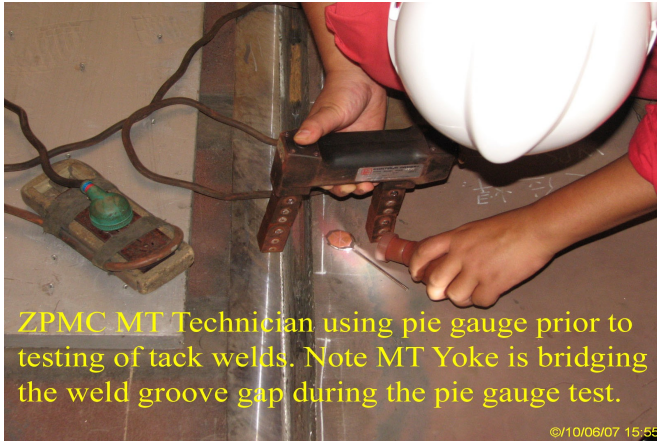
This Quality Assurance (QA) Inspector observed ZPMC Magnetic Particle Testing (MT) Technician, Zhou Dong Yun testing the tack welds on the 89 Meter Mock-Up, MA24 Skin Plate Sub-Assembly (Face B), weld joint 5/6 joining MA24 to mp505. It was noted during the testing that Mr. Zhou was placing his MT yoke at 45 degree angles to the direction of welding instead of the conventional zero/ninety degrees. Mr. Zhou was being very methodical in ensuring the each area was tested in two directions perpendicular to one another. Prior to testing Mr. Zhou tested the MT Yoke by placing the yoke across the weld gap and using a pie gage verify direction of field and a lift test was also performed. 10% QA verification MT was conducted, for details see TL-6028 dated October 6, 2007.
